# Harwin Test Report Summary

**HT04301**

M300 Connector Series Testing  
Electrical, Mechanical & Environmental

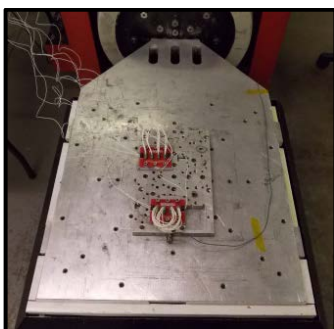
X-axis typical setup

Method: 2 samples of all types of connectors listed in section 2.1, in cable-to-board combinations, were subjected to above Condition II vibration in all 3 Axes, while being monitored for discontinuities of 1 millisecond or more using a constant current source of 100mA. Parts were visually inspected for damage or wear before and after. The same samples were then tested again to a higher level of vibration: Condition IV – 10Hz to 2000Hz, 1.52mm, 196.1m/ s<sup>2</sup> (20G), 12 hours.

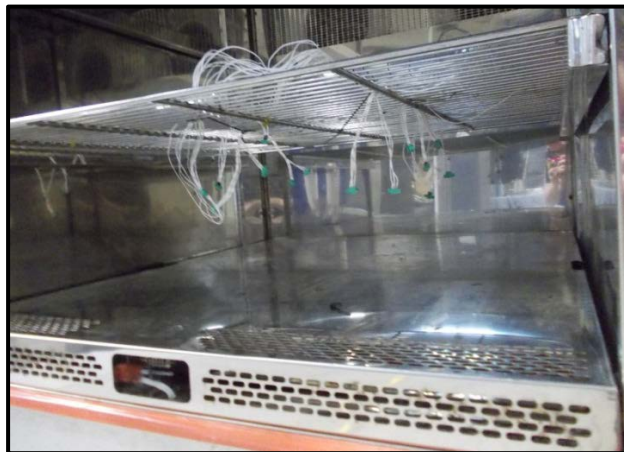
Method: Samples of all cable-to-board, mated and un-mated pairs of connectors listed in section 2.1 were prepared with sufficient lengths of wire, and suspended vertically in a drying oven while having a polarising voltage applied. They were subject to 50°C for 24 hours. Immediately after conditioning, the samples were measured for bulk contact resistance (including test circuit) in ambient conditions. The samples were returned to the test chamber with a 100V DC polarising voltage, a relative humidity of 90-95% and 40±2°C. After 96 hours, a sample of each type was removed, leaving the remaining samples to complete the 56 day period. Bulk contact resistance on 1 control sample was measured immediately after removal from the test chamber. All samples were measured after 5 hours (to recover to standard ambient conditions).

Mated or Un-mated Connector Pair Type	Pre-Test bulk Contact Resistance	Post-Test bulk Contact Resistance	5 hrs Post-Test bulk Contact Resistance	Observations
Female Cable / Male PC Tail SIL 3 Position, Mated	0.138 Ω max.	n/a	0.140 Ω max.	None
Female PC Tail / Male Cable SIL 3 Position, Un-Mated	0.138 Ω max.	n/a	0.140 Ω max.	None
Female Cable / Male PC Tail DIL 6 Position, Mated	0.138 Ω max.	0.138 Ω max.	0.138 Ω max.	None
Female PC Tail / Male Cable DIL 6 Position, Un-Mated	0.139 Ω max.	n/a	0.141 Ω max.	None

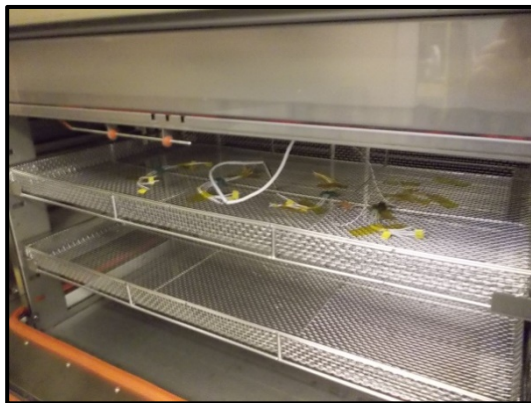
These samples were then placed in a Temperature Cycling oven as shown, cycled 5 times from +175/178°C to -65/70°C with dwell time 30 minutes min. Parts were then removed from the oven and allowed to return to ambient temperature before final checks were made.
